**SERIAL NUMBERS 11 TO 20
GROUNDING CASES**

NAVY DEPARTMENT - - Bureau of Navigation

Prepared by the Training Division
Bureau of Navigation

UNITED STATES
GOVERNMENT PRINTING OFFICE
WASHINGTON : 1930

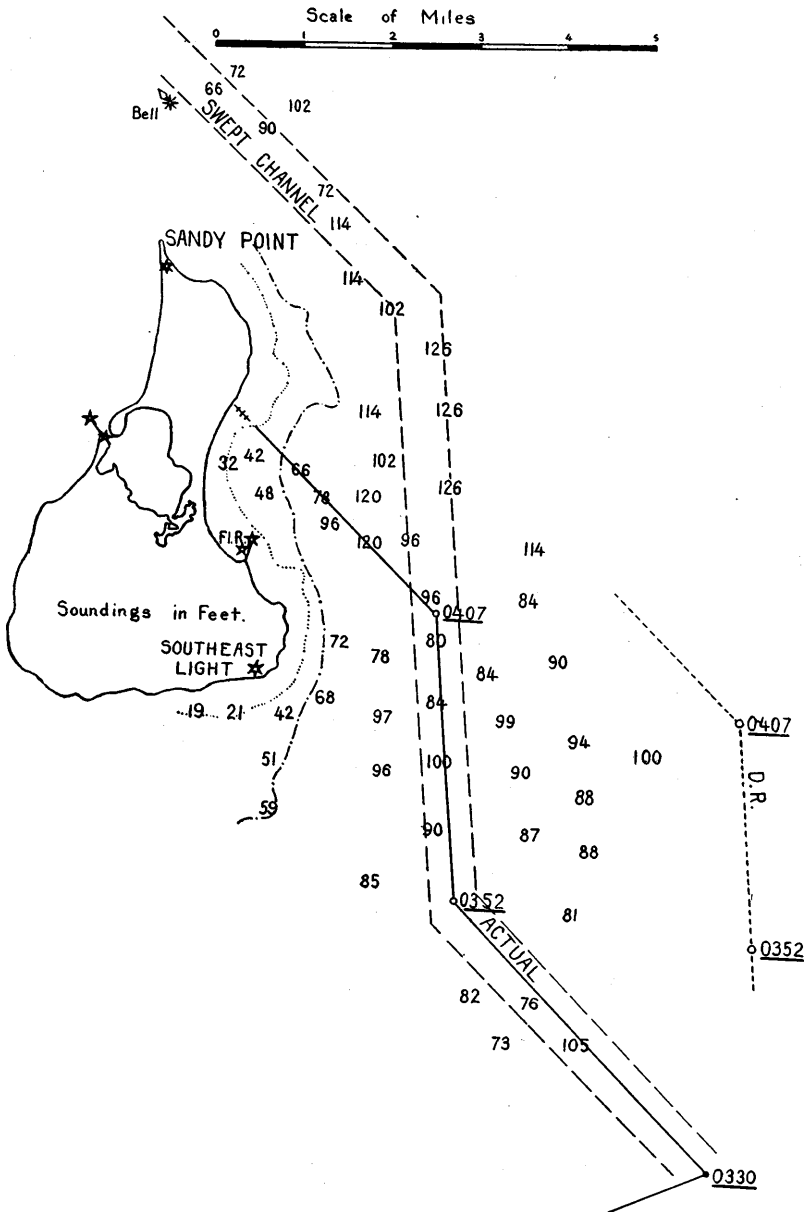
FIGURE 1

Southeast Light on Block Island was sighted at 0258 bearing 7° true. The position was located on this bearing by using the distance run from the time Montauk Point Light was abeam and the position at that time.

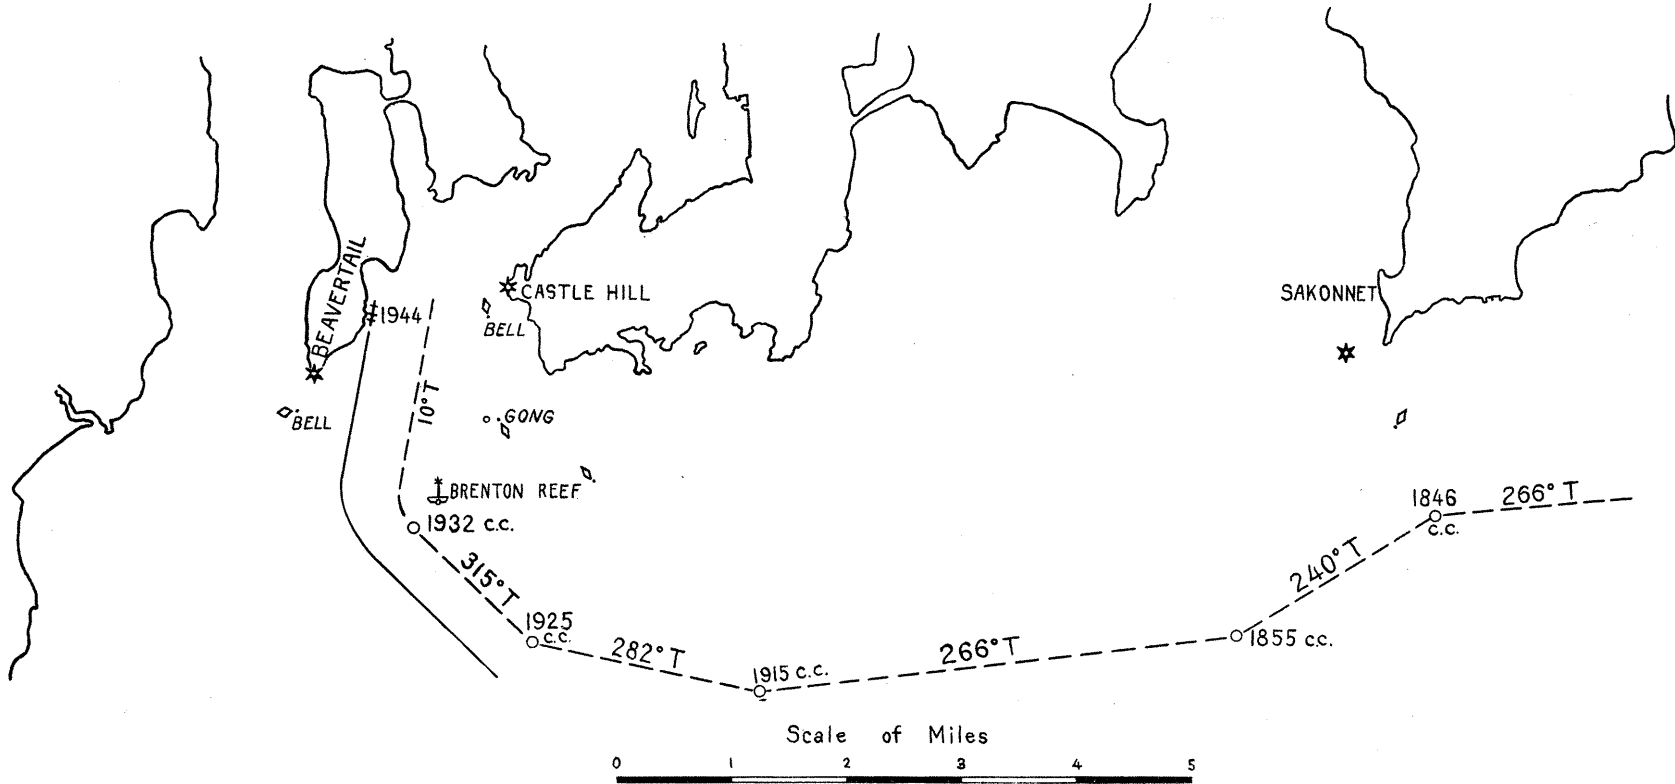
FIGURE 2

He said that he had made no allowances for set due to the tidal current. When Sakonnet Light was in sight he believed that the ship was being set in toward the beach, so he made the change of course at 1845 without telling the commanding officer.

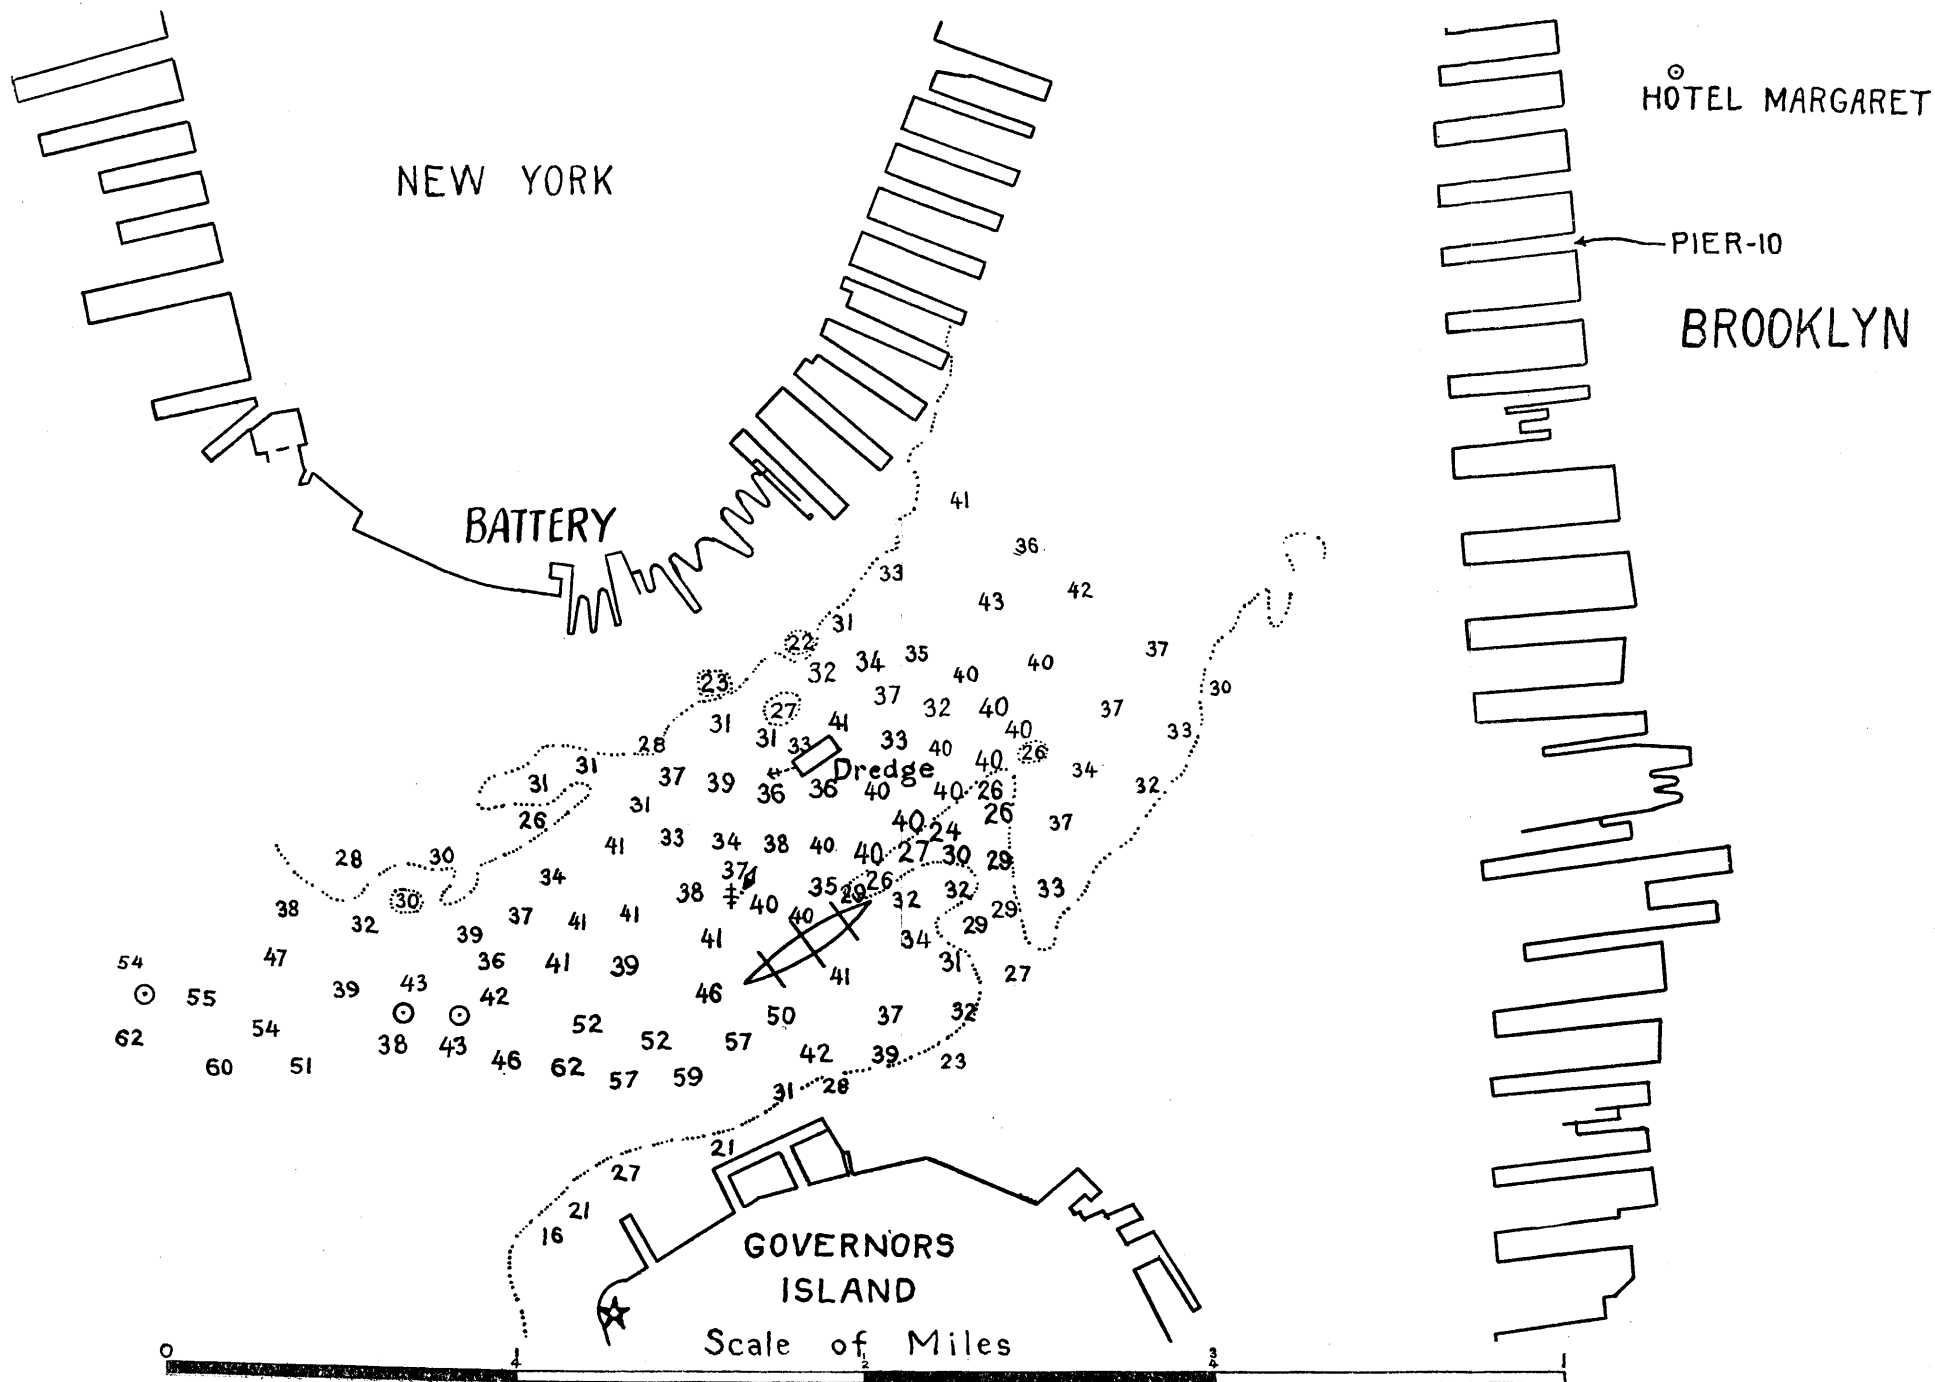
FIGURE 4

She now crossed over the deep-water range, and stood over to the south side of the channel toward Governors Island. The pilot gave the order to "Left rudder," followed by "Left full rudder." He suggested that the port engine be backed two-thirds; the executive repeated the order. The ship's head did not seem to swing, so the order was given, "Back full speed on the port engine," and the starboard was stopped. At the same time the tugs on the starboard bow

were directed by the pilot to go ahead in the attempt to shove the bow over to port and back onto the range.

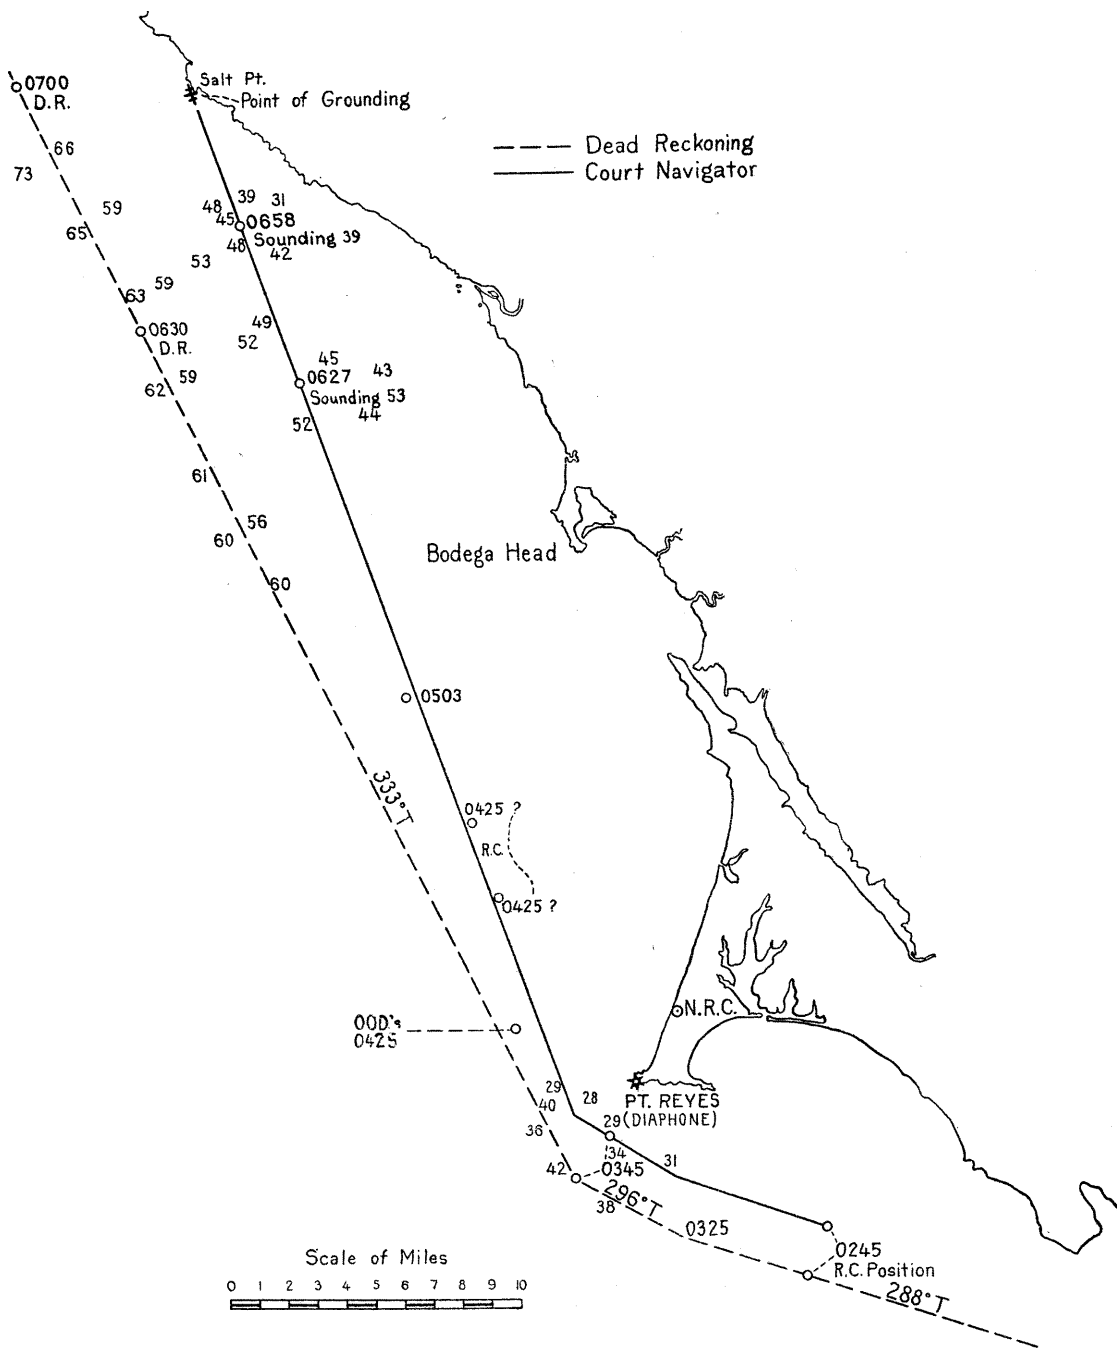
Farallon

At this point the navigator advised the officer of the deck to change the course to the westward, to course 318° true. The deviation on this course was not known, so both the officer of the deck and navigator went into the emergency cabin in order to pick out the correct deviation and from that obtain the compass course. While they were inside the starboard bridge lookout sang out, "Rocks ahead." Both the officers rushed onto the bridge and the order was given, "Full speed astern, both engines, left full rudder." Before the engines could take charge and the ship be backed clear, she grounded on the rocks off what was later determined to be Salt Point.

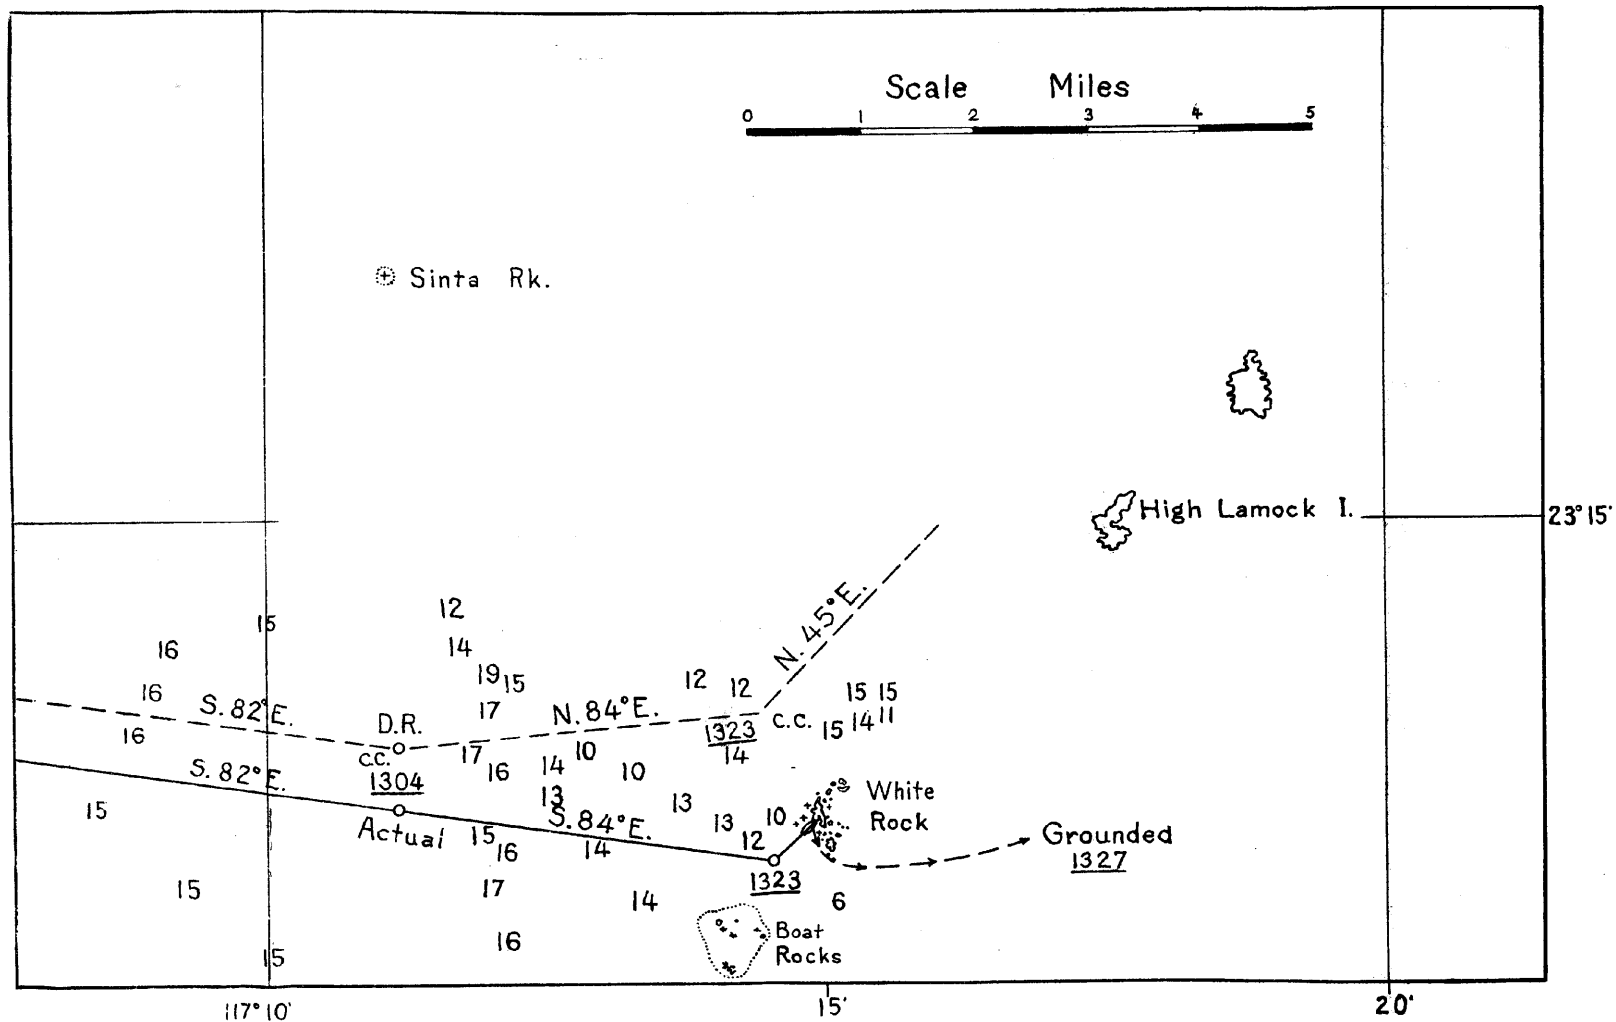
FIGURE 7

The course was changed but the officer of the deck did not report the fact that the ship was steadied on the new course to the captain. The captain noticed this and called to the officer of the deck and

asked him why he had not reported when on the new course. The officer of the deck replied, "I did not know that I had to when you were on the bridge."

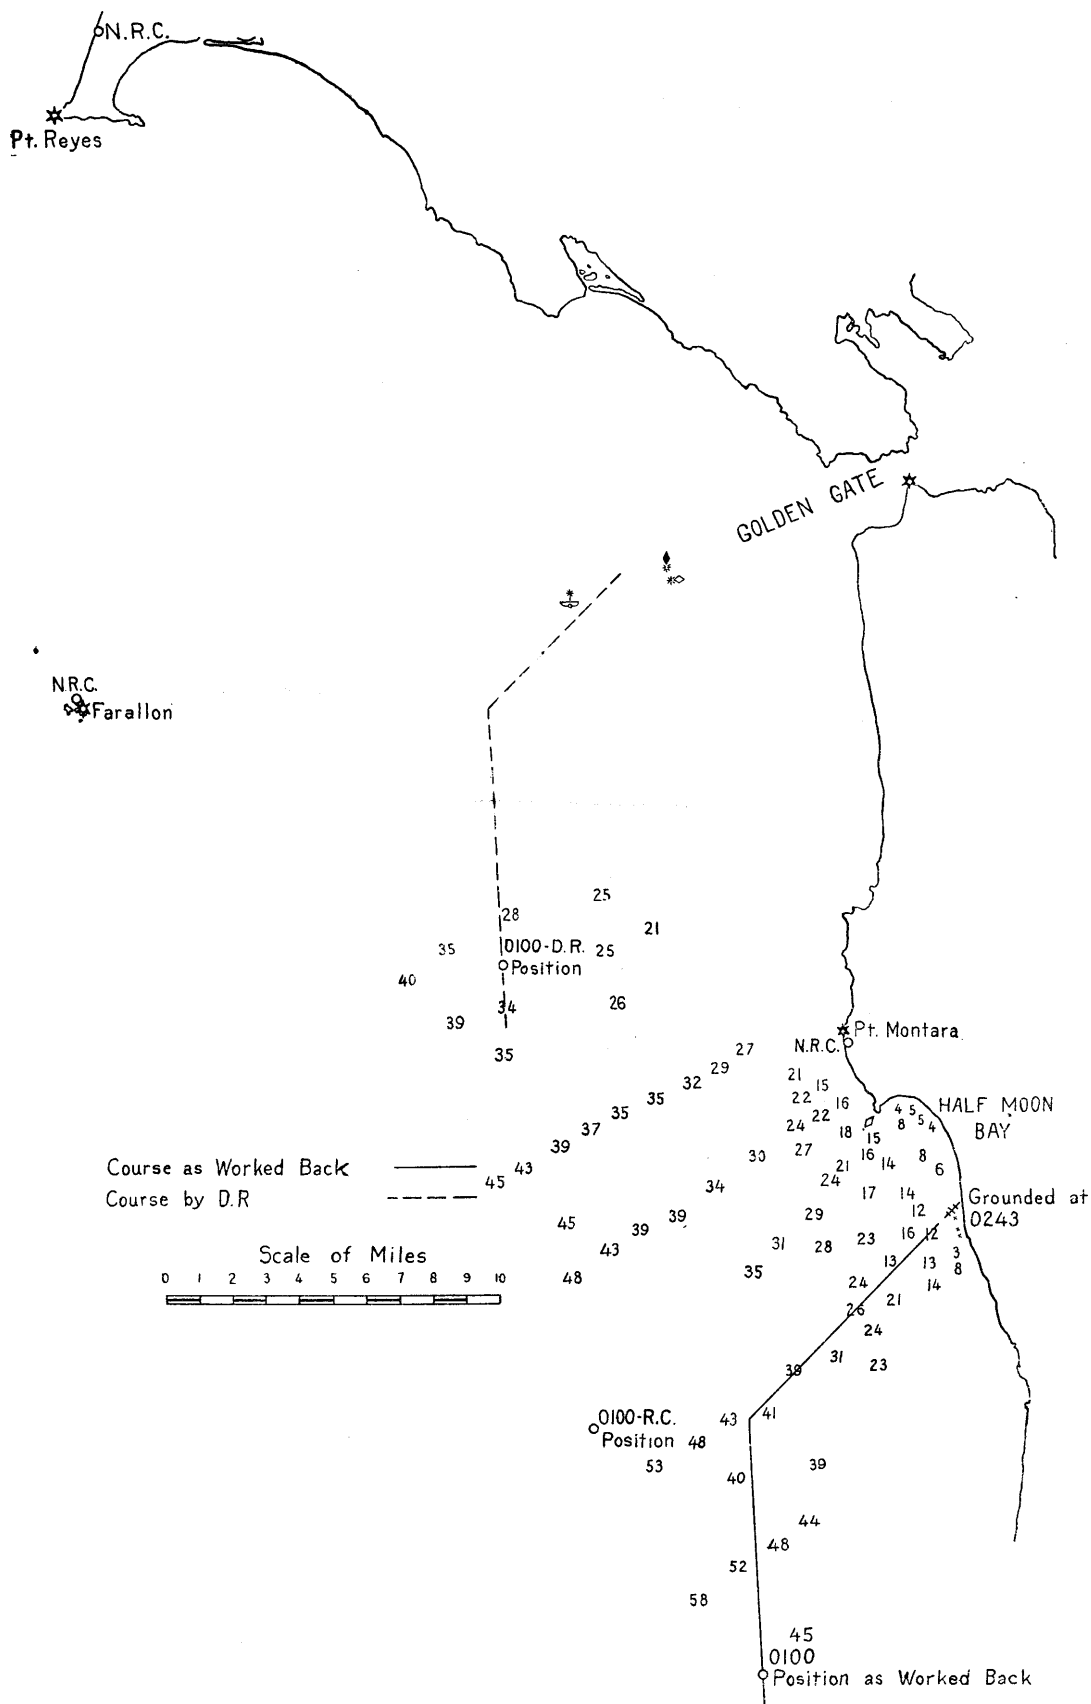
At 0243 the ship struck bottom and remained hard and fast aground. Immediately the danger signal was sounded and break-

down lights shown. The three ships in company with the *Good* did not go aground.
